**Certificate of Conformance for Freight Container Mechanical Seal Testing**  
**Seal Classification: High Security Seal**

Test Report No. : L0830272-T01

SUBJECT : Freight containers Mechanical seals classification Testing

Type: 2K MEGALOCK (2K ML)

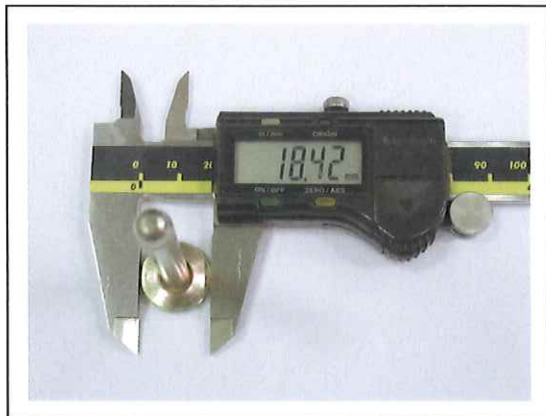
Specimen No.	Measurement (mm)		Pass/Fail
	000086	Pin Head	
Lock Body		18.22	Pass

The minimum diameter (or minimum widest cross-dimension) for the metal components of a bolt seal shall be 18 mm.

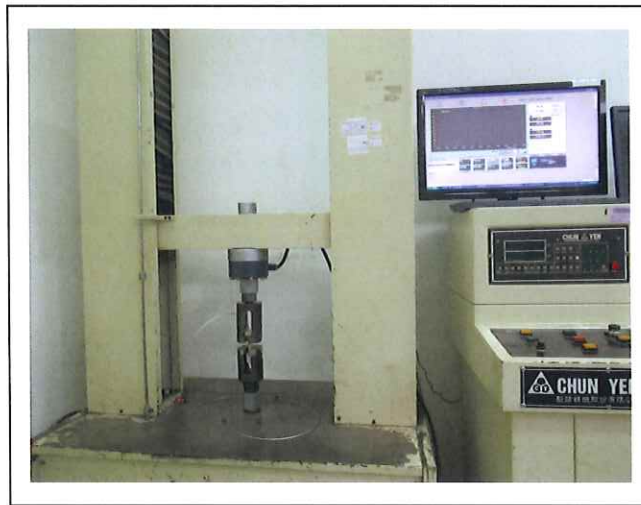
Testing Instrument : Universal Testing Machine (No.TG0103)

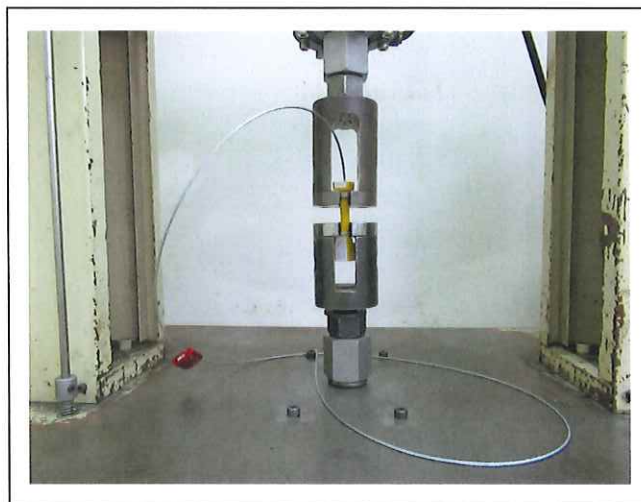
Tensile Set up

The seal was gripped in a tensile machine and a pull force applied.

Specimen No.	Requirement Load to failure	Result kN	Seal classification
000061	10.0 kN : High security seal 2.27 kN : Security seal < 2.27 kN : Indicative seal	26.9	High security seal (H)
000062		24.4	High security seal (H)
000063		21.7	High security seal (H)
000064		22.8	High security seal (H)
000065		24.1	High security seal (H)

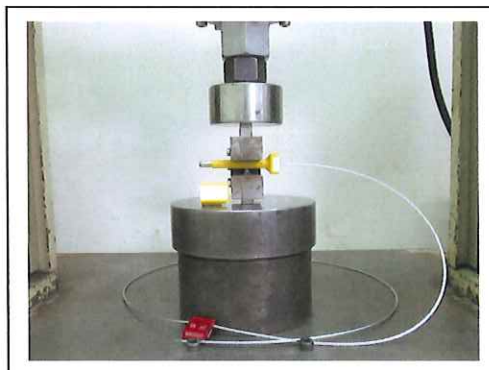
Shear Set up

The seal was fixed in a universal testing machine to withstand cutting with shearing blades and a compressive load applied slowly until the seal is severed.

Specimen No.	Requirement Load to failure	Result kN	Seal classification
000066	3.336 kN : High security seal 2.224 kN : Security seal <2.224 kN : Indicative seal	8.896	High security seal (H)
000067		8.896	High security seal (H)
000068		8.896	High security seal (H)
000069		8.896	High security seal (H)
000070		8.896	High security seal (H)

**SAFETY PRECAUTIONS** - Do not exceed a shear force greater than 8900N(2001lbf) .If the specimen has not failed at that force, halt the test and unload the test equipment. Record a shear force of 8896N (2000 lbf).Sudden and violent rupture of the test specimen can endanger personnel, equipment and property.

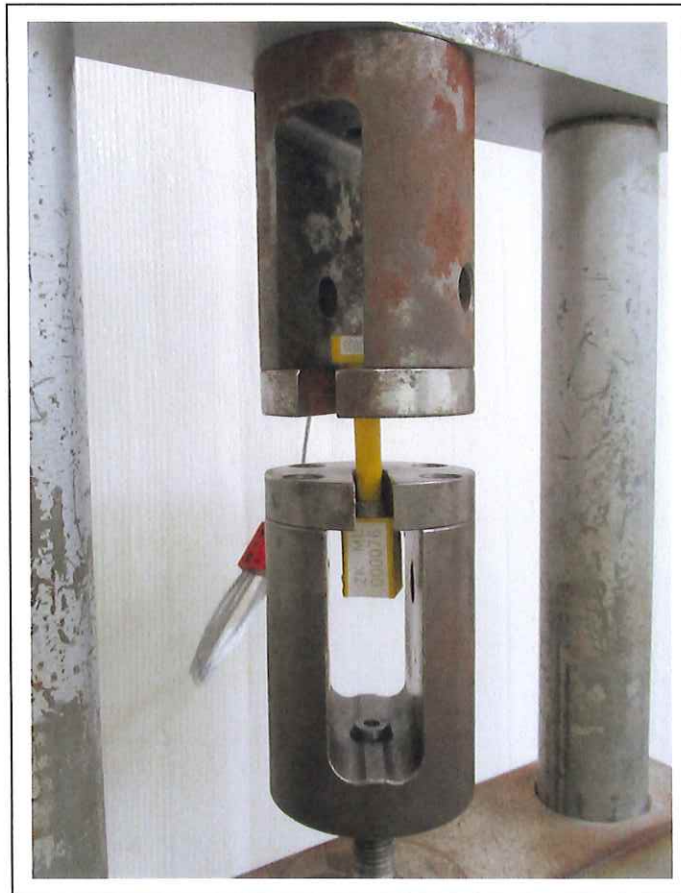
Impact Set up

The impact test is performed at 18 degrees C and minus 27 degrees C of temperature.  
The impact load is applied at the locking mechanism of the seal in the direction opposite the direction used in locking the seal.

<b>Impact Test at 18 °C</b>					
Specimen No.	Requirement	Result Joule			Seal classification
		13.56	27.12	40.68	
000076	40.68J : High security seal 27.12J : Security seal <27.12J : Indicative seal <b>5 impacts at each load</b>	Pass	Pass	Pass	High security seal (H)
000077		Pass	Pass	Pass	High security seal (H)
000078		Pass	Pass	Pass	High security seal (H)
000079		Pass	Pass	Pass	High security seal (H)
000080		Pass	Pass	Pass	High security seal (H)

<b>Impact Test at -27 °C</b>					
Specimen No.	Requirement	Result Joule			Seal classification
		13.56	27.12	40.68	
000081	40.68J : High security seal 27.12J : Security seal <27.12J : Indicative seal <b>5 impacts at each load</b>	Pass	Pass	Pass	High security seal (H)
000082		Pass	Pass	Pass	High security seal (H)
000083		Pass	Pass	Pass	High security seal (H)
000084		Pass	Pass	Pass	High security seal (H)
000085		Pass	Pass	Pass	High security seal (H)
