Certificate of Conformance for Freight Container Mechanical Seal Testing
Seal Classification: High Security Seal

試驗報告 TEST REPORT

SUBJECT : Freight containers Mechanical seals classification Testing

Type: MEGALOCK (ML)

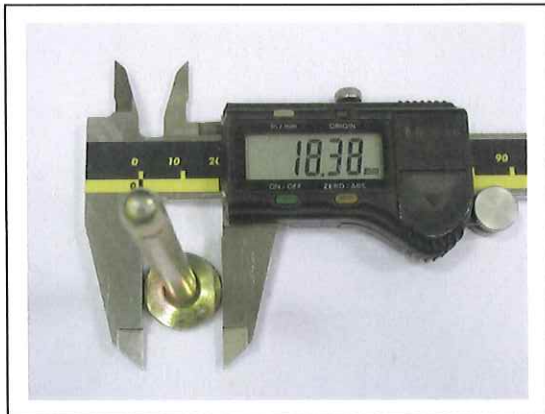
Specimen No.	Measurement (mm)		Pass/Fail
000086	Pin Head	18.38	Pass
	Lock Body	18.15	Pass

The minimum diameter (or minimum widest cross-dimension) for the metal components of a bolt seal shall be 18 mm.

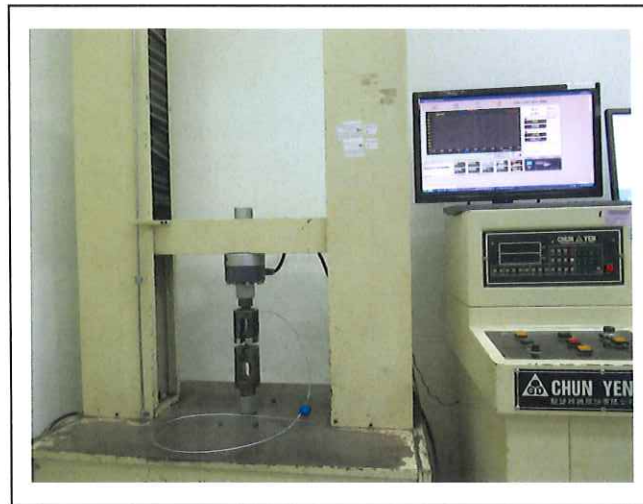
Testing Instrument : Universal Testing Machine (No.TG0103)

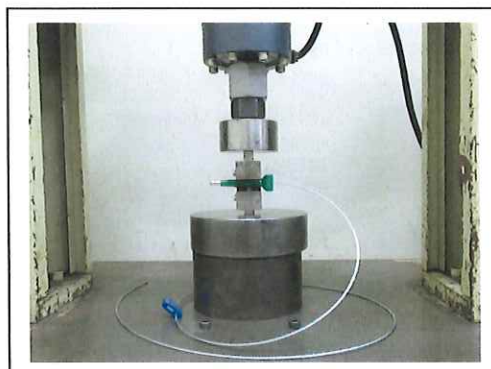
Shear Set up

The seal was fixed in a universal testing machine to withstand cutting with shearing blades and a compressive load applied slowly until the seal is severed.

Specimen No.	Requirement Load to failure	Result kN	Seal classification
000066	3.336 kN : High security seal 2.224 kN : Security seal <2.224 kN : Indicative seal	8.896	High security seal (H)
000067		8.896	High security seal (H)
000068		8.896	High security seal (H)
000069		8.896	High security seal (H)
000070		8.896	High security seal (H)

SAFETY PRECAUTIONS - Do not exceed a shear force greater than 8900N(2001lbf) .If the specimen has not failed at that force, halt the test and unload the test equipment. Record a shear force of 8896N (2000 lbf).Sudden and violent rupture of the test specimen can endanger personnel, equipment and property.

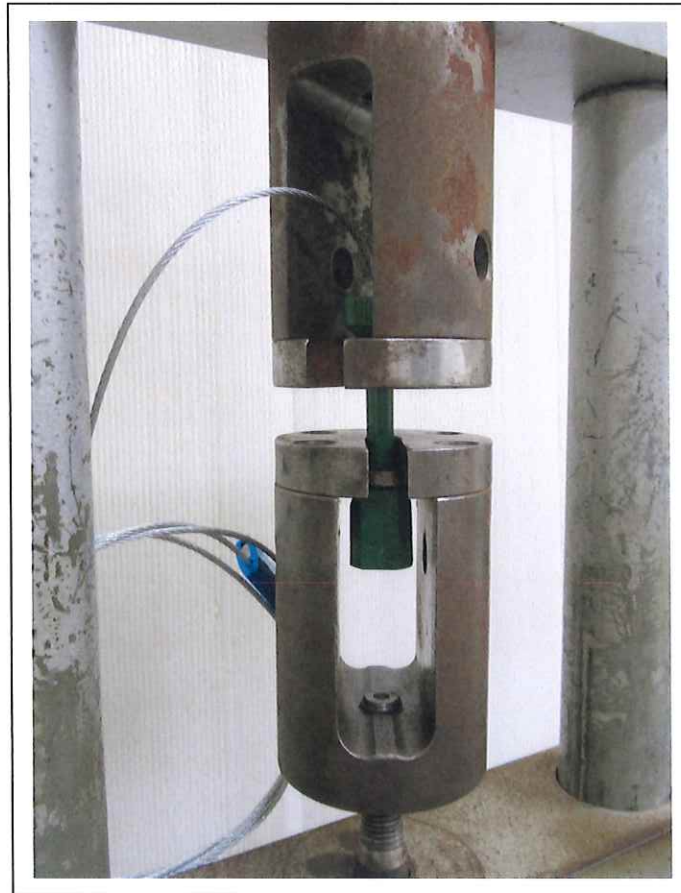
Impact Set up

The impact test is performed at 18 degrees C and minus 27 degrees C of temperature.
The impact load is applied at the locking mechanism of the seal in the direction opposite the direction used in locking the seal.

Impact Test at 18 °C					
Specimen No.	Requirement	Result Joule			Seal classification
		13.56	27.12	40.68	
000076	40.68J : High security seal 27.12J : Security seal <27.12J : Indicative seal 5 impacts at each load	Pass	Pass	Pass	High security seal (H)
000077		Pass	Pass	Pass	High security seal (H)
000078		Pass	Pass	Pass	High security seal (H)
000079		Pass	Pass	Pass	High security seal (H)
000080		Pass	Pass	Pass	High security seal (H)

Impact Test at -27 °C					
Specimen No.	Requirement	Result Joule			Seal classification
		13.56	27.12	40.68	
000081	40.68J : High security seal 27.12J : Security seal <27.12J : Indicative seal 5 impacts at each load	Pass	Pass	Pass	High security seal (H)
000082		Pass	Pass	Pass	High security seal (H)
000083		Pass	Pass	Pass	High security seal (H)
000084		Pass	Pass	Pass	High security seal (H)
000085		Pass	Pass	Pass	High security seal (H)
